Detailed C-54 Loss Reconstruction **Drift, Crew Actions, and Probable Site**

1. *Timeline & Cockpit Sequence*

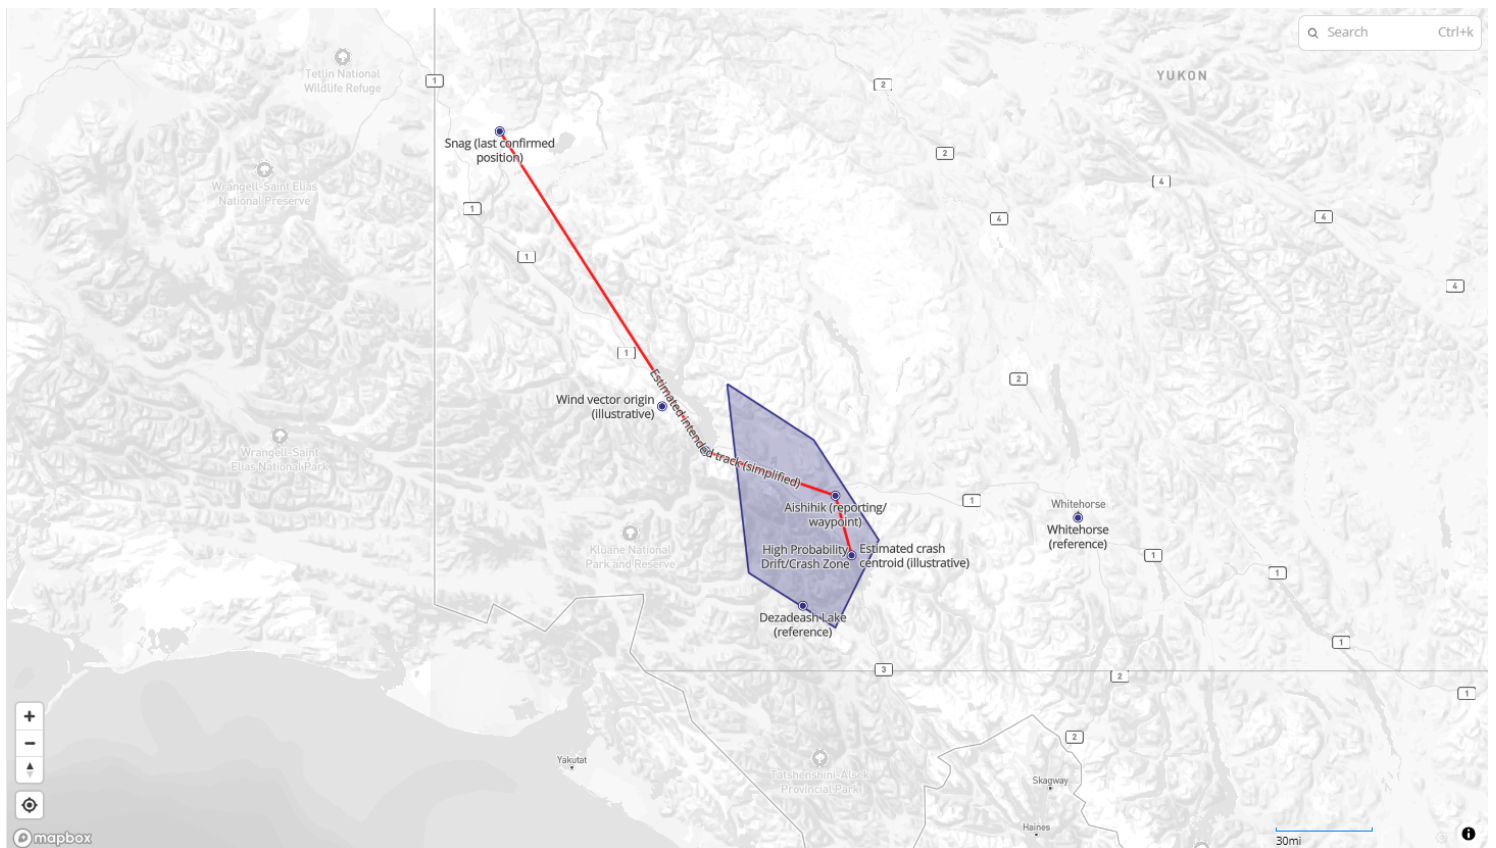
Southern reference near the suspected crash band.
Polygon (High Probability Drift / Crash Zone)

This polygon is the mapped “high probability” area derived from your synopsis (20–50 nm S/SE of Aishihik, overlapping Kluane/Dezadeash and the northern slopes of the St. Elias).

Approximate extents: east–west span $\approx 1.4^\circ$ lon (~ 40 nm at $\sim 61^\circ$ N); north–south span $\approx 1.1^\circ$ lat (~ 66 nm). (Use these as coarse search-box dimensions; terrain and snow cover make visual detection difficult.)

Start: Snag (-140.400, 62.400)
Mid: Kluane reference (-138.500, 61.000)
Mid: Aishihik (-137.300, 60.800)
End (terminates inside polygon): (-137.150, 60.530)

Straight-line simplification of Amber-2 airway from Snag toward Aishihik and continuing into the high-probability polygon. Render as a red stroke on maps to show intended route + likely final track into the search zone.

Centroid (illustrative): (-137.150, 60.530)

Uncertainty: radial band 20–50 nautical miles from Aishihik (per synopsis).

Winds aloft ~ 340 – 352° at 40–45 kt (from NNW). This would push the aircraft to the right of an intended SE heading, producing significant drift toward S/SE (report estimate of ~ 35 – 38 kt cross-track effect).

Use this polygon as the primary LIDAR search priority, then expand along the SSE band described in the report.

20 nm ≈ 37 km; 50 nm ≈ 93 km. Treat the centroid as an illustrative focus point but plan searches to cover the full 20–50 nm SSE band.
